## Early Connections Antlers Place

### Project Statement

January 18<sup>th</sup>, 2022

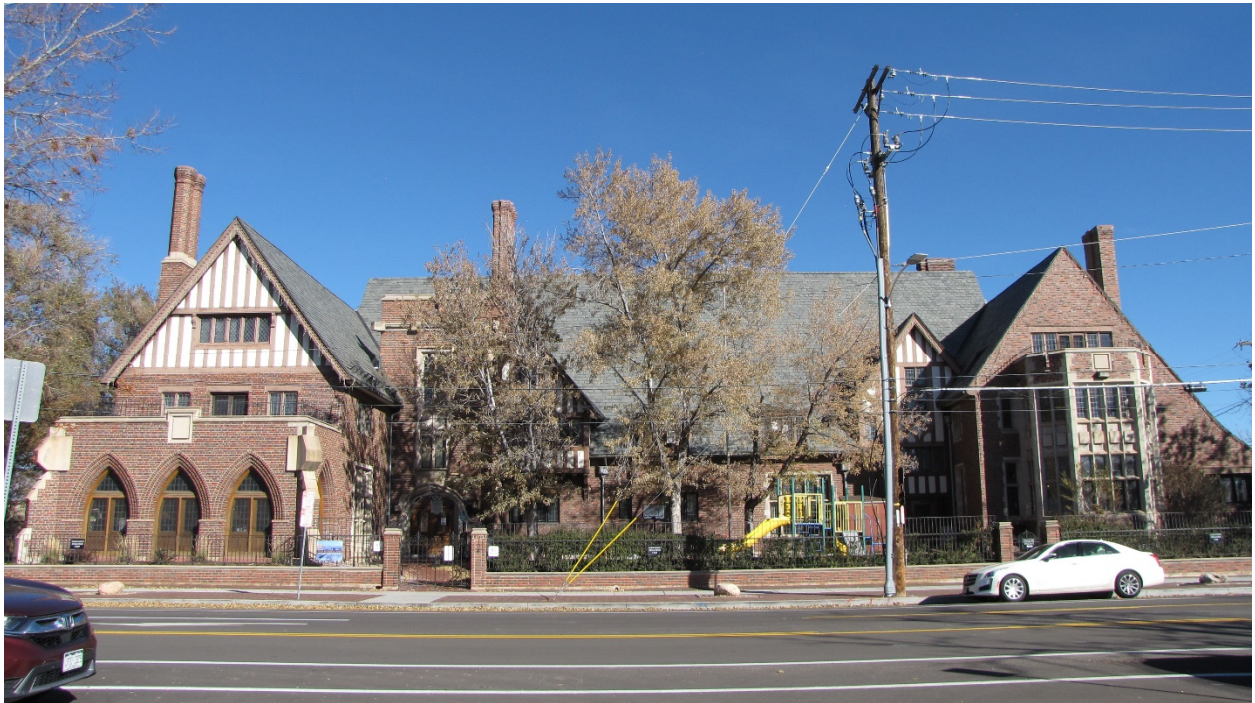
The historic day nursery building at 104 E Rio Grande St. is the design inspiration for the new facility. This 1928 building is not only a treasure to Colorado Springs but is a symbol of the mission of Early Connections Learning Centers to provide early childcare to working parents in need while providing a beautiful space for the children to spend their days. The design of the new facility reflects the Tudor mansion aesthetic with playful whimsy so the children know it was created just for them. As with the historic day nursery, the playground spaces will be front and center to provide a safe and interesting environment for the children. Vines growing up the walls of the historic day nursery building will also be used at the new facility to soften the edges of the new retaining walls along the parking lot and raised playground spaces.

*South façade of the historic day nursery building with playground and brick/iron fencing at sidewalk edge.*

MSE type retaining walls will be used to protect the existing tree root system by eliminating a deep footing needed for a traditional retaining wall. A stamped brick pattern on the face of the MSE wall and stained concrete will be used to give the impression of a brick wall similar to the historic day nursery site wall and fence.

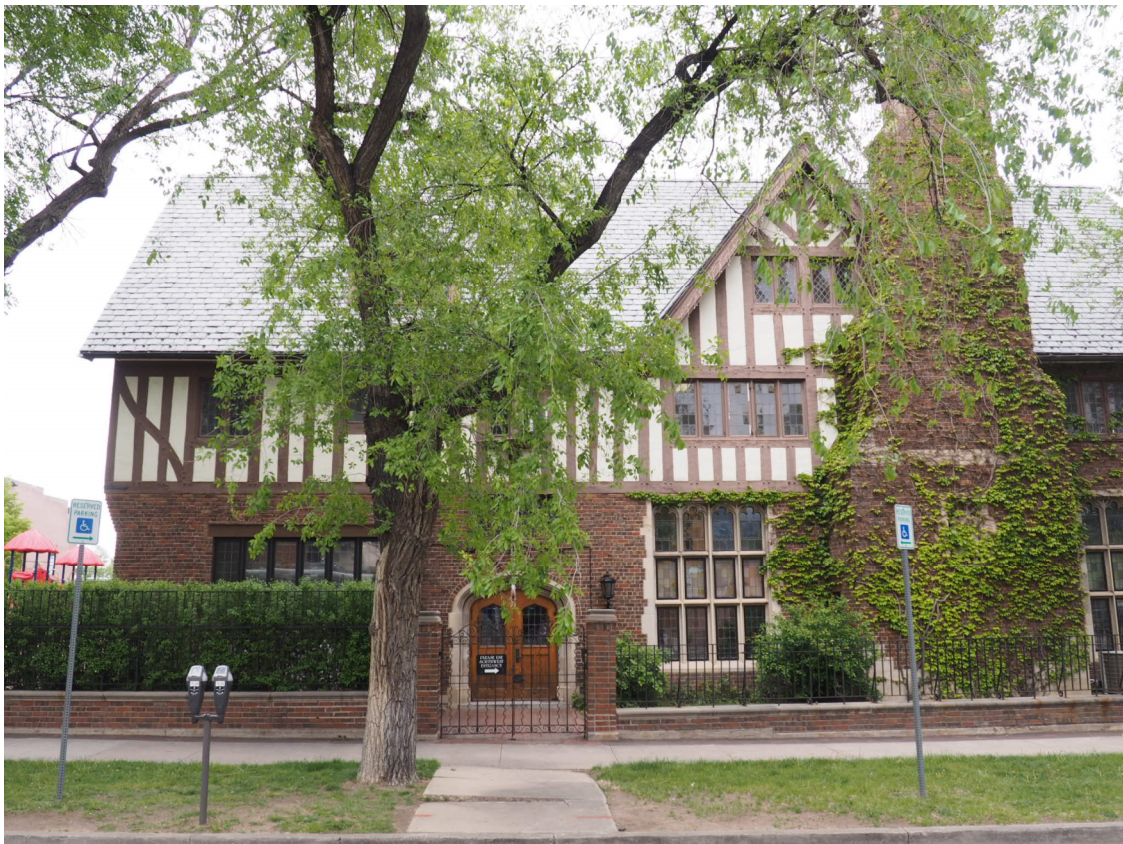
*West façade of the historic day nursery building*
