Alice Bemis Taylor Center for Early Education

Project Statement

January 10th, 2025

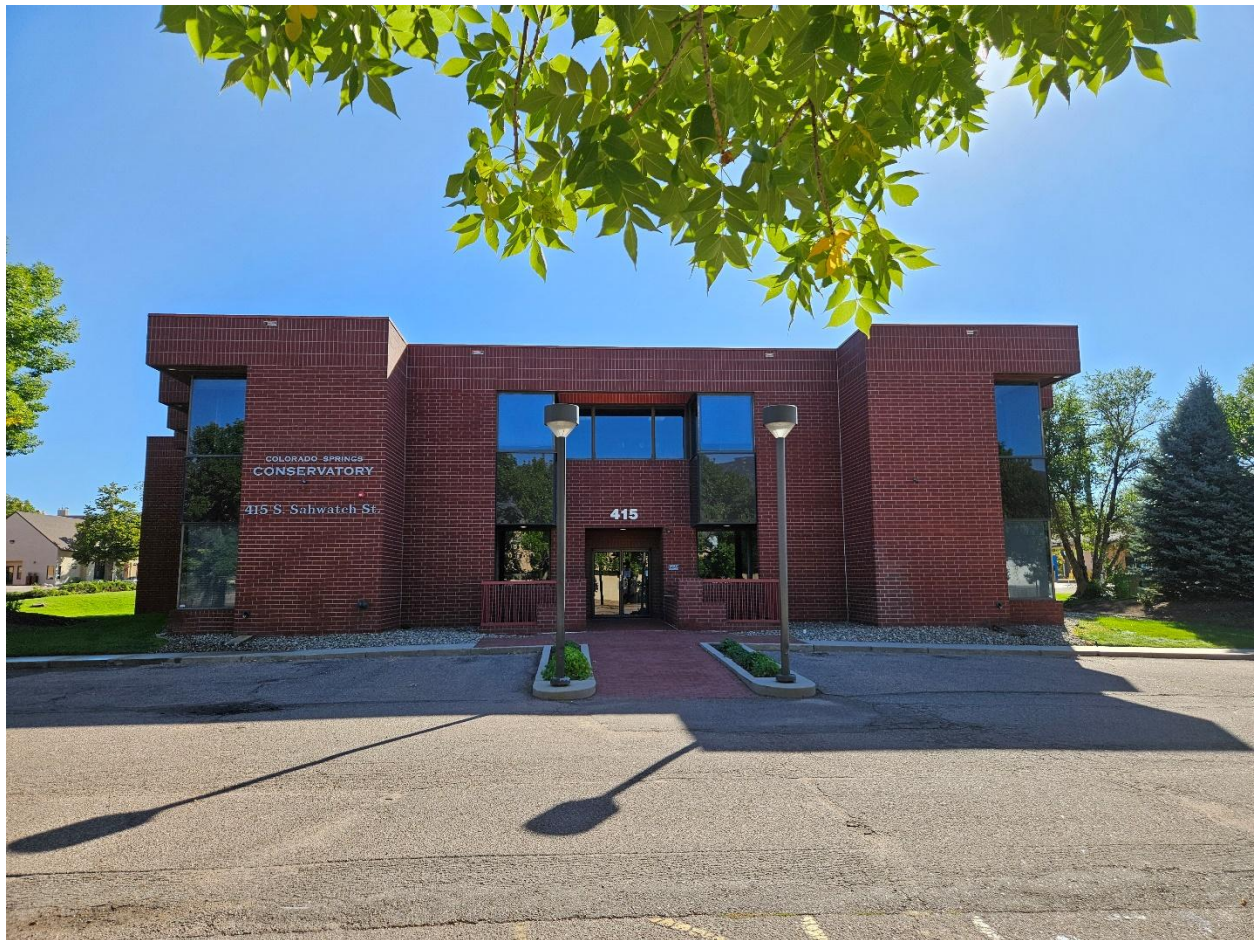
The existing entry bridge is to be reconstructed and enhanced with a canopy structure

While much of the exterior of the building will remain as is, alcoves in the exterior facade on the east side will be infilled and clad with a prefinished metal panel to provide more continuous interior space on the ground and second levels. An interior mezzanine floor that is currently not an ADA accessible space will be removed to provide a continuous accessible floor plate at the 2nd level. The existing roofing is to be replaced along with the top of wall coping. A canopy structure is to be constructed to protect the main entrance from the elements and to provide a more recognizable entry point. Colorful applied graphics and signage applied to the existing building will lend a playful identity to the otherwise formal and serious appearance of the existing building.

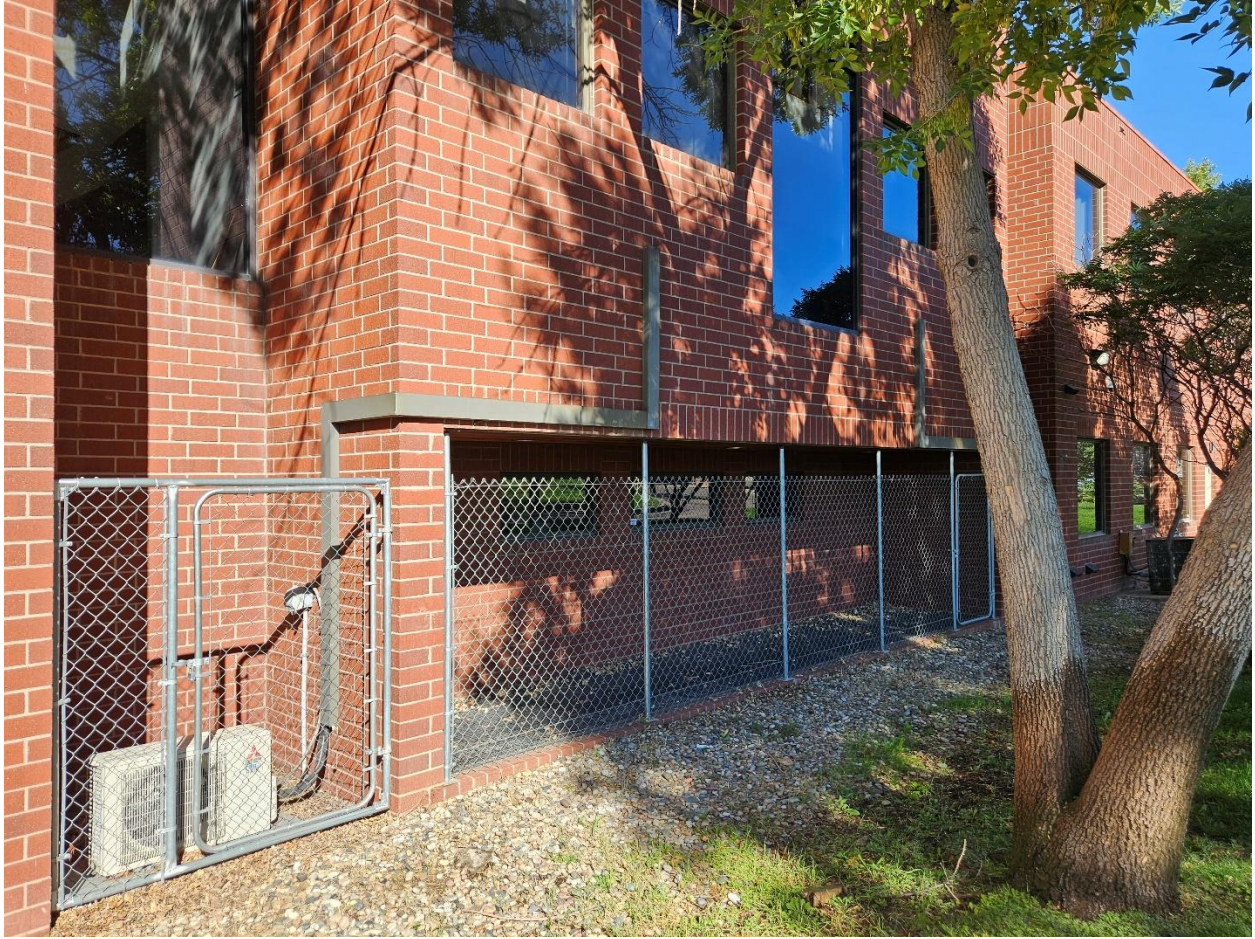
Existing alcoves on the east side of the building are to be infilled to increase usable interior area

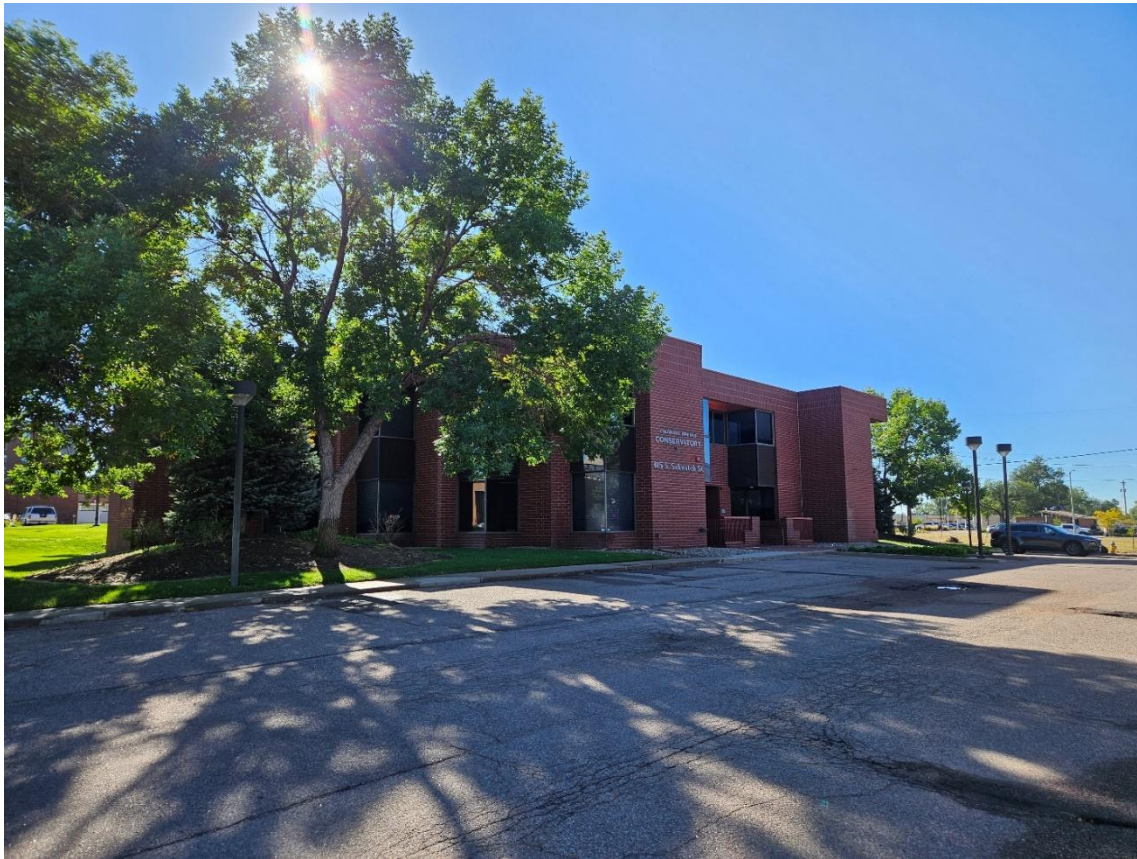
Existing trees will provide shade for outdoor play areas and will allow students to “explore” a natural play area

This design capitalizes on the presence of mature trees, which are integrated not only within the playgrounds but also along the site's perimeter, enriching the pedestrian experience and providing valuable shade. The landscape strategy includes a diverse selection of perennials, ornamental grasses, and evergreen shrubs along the new playground fence line, effectively softening its edge. Meanwhile, existing lawn areas are preserved within the amenity zone. These thoughtful elements, combined with the joyful sounds of children at play, create an engaging and pleasant experience for pedestrians and contribute to the Downtown Colorado Springs area as an exemplary model of civic and environmental design.

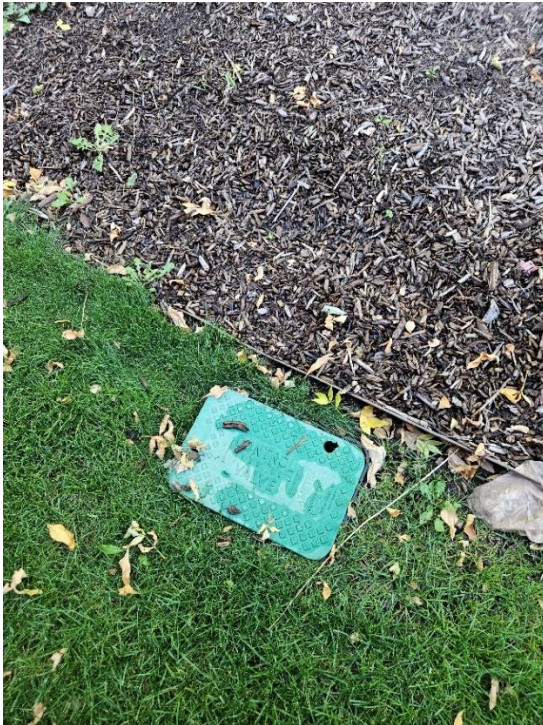
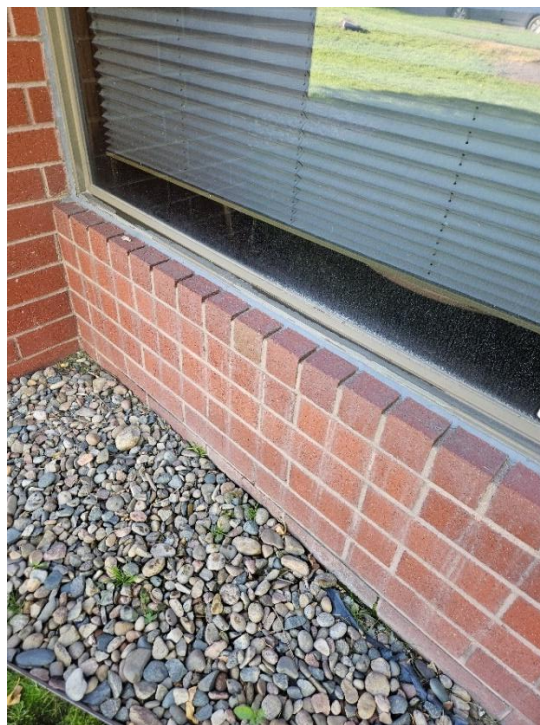
Much of the existing turf grass, gravel and mulch is to be replaced with landscaping materials appropriate for outdoor play areas

Fenced playgrounds are required for an early education center and will occupy the existing landscaped areas on the north and south sides of the building. Site renovations will replace the existing mulch, gravel and turf grass with areas of artificial playground turf, rock mulch, engineered wood fiber and poured-in-place rubber which have been selected as appropriate and safe surfacing for the outdoor play areas. All but one tree will remain where the playground areas will occupy the site. The play areas will be designed to incorporate these existing mature trees to both provide necessary shade and allow students to interact with them. This “natural play” concept has also informed playground equipment and amenity selection to provide further immerse students and promote an exploratory outdoor experience.
