Early Connections Antlers Place

Project Statement

January 18th, 2022

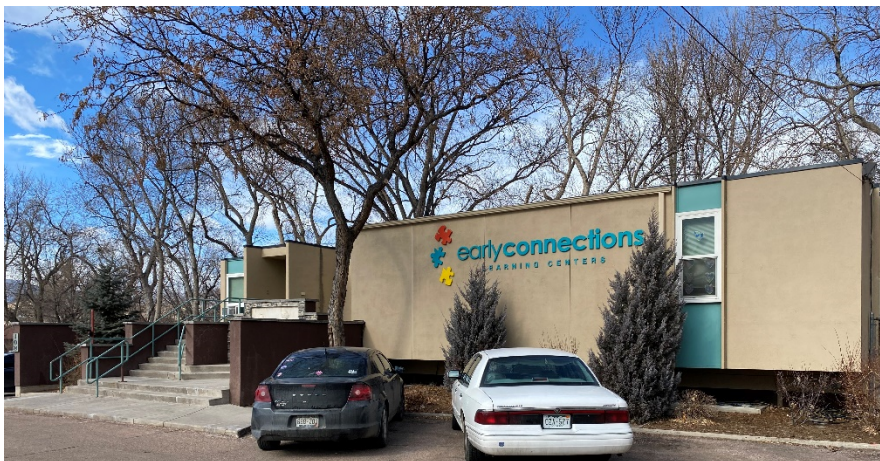
Existing 1952 building without an accessible entrance.

The site is comprised of one lot on the corner of Antlers Place and S Sierra Madre. The site shares a lot line to the north with Antlers Park and is zoned FPZ. The site contains a 7,300 SF early childhood education center built in 1952. The building does not meet the current standards of a licensed childcare facility and has been granted waivers to continue to operate because of the high need for such facilities in the downtown area. The capacity of the current facility also does not meet the current demand and has many ADA accessibility issues. On this site there is also two storage sheds, three fenced playground areas and a gravel/asphalt parking lot.

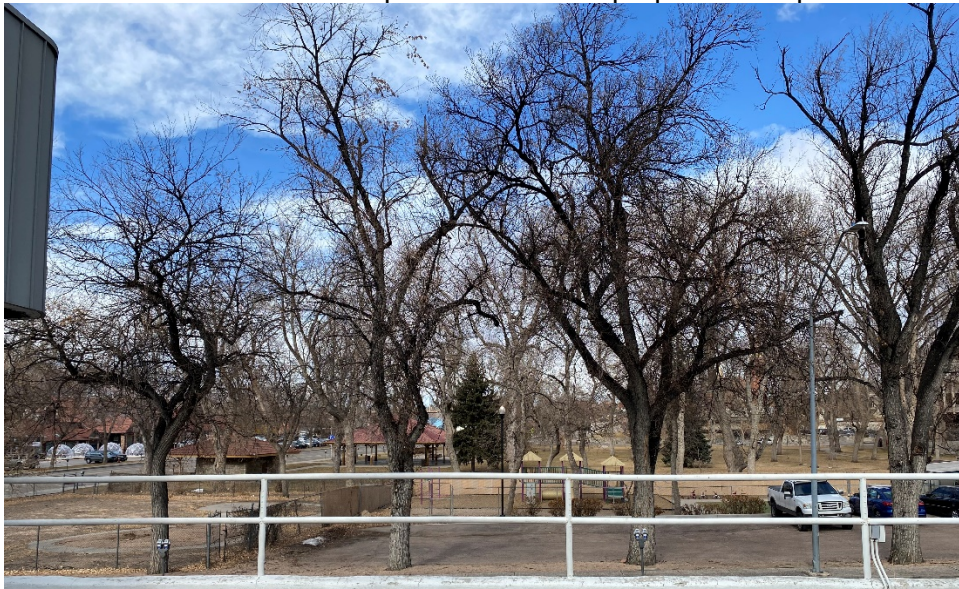
Elm Trees along Antlers Place with a fungus that has blackened the bark of the trees.

The trees along the shared Antlers Park lot line are property of the City and are considered historic. In April of 2021 the design team met with Dennis Will, the City Forester to review and assess the existing park trees. Dennis Will referred the design team to Becky Wegner to assess the health of the remaining trees not on City property. The trees within the park boundary are mostly ash and elm trees and are in good condition for their age. The trees along the south edge of the early connection property are elm and have not received the same care. They show signs of a fungus and have not been trimmed up or treated. Becky assisted in selecting the healthiest mature trees to preserve along this edge as shown in the proposed site plan. The trees along the west edge of the property are ash and are in much better condition despite the lack of care. These trees are shown to be preserved on the proposed site plan.

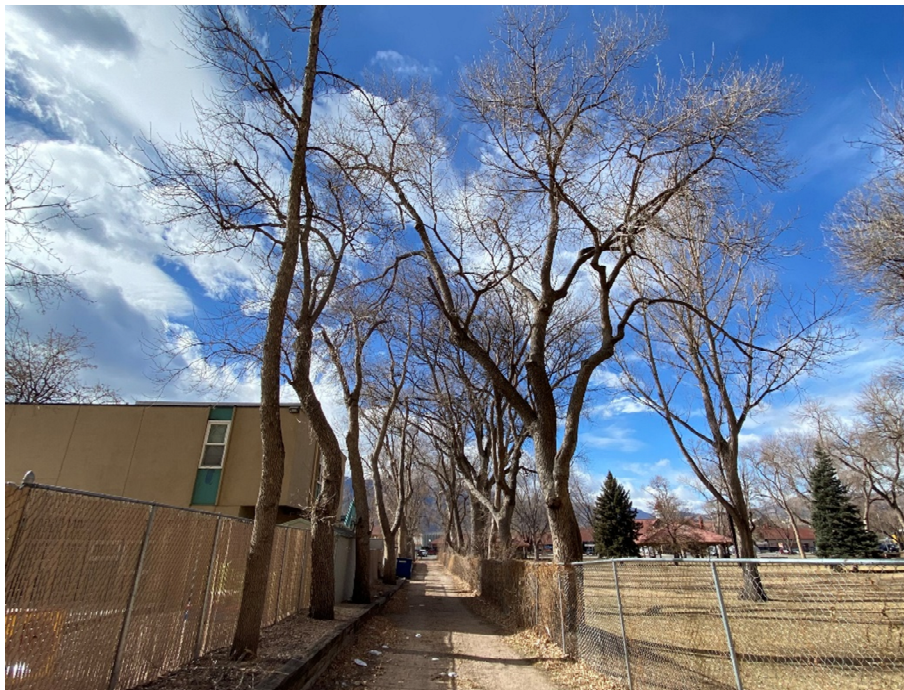
Historic Antlers Park trees (right side of chain link fence)

The historic trees in Antlers Park have been protected by siting the building outside of the tree's drip line. The ash trees along S Sierra Madre and the two healthy elm trees along Antlers Place

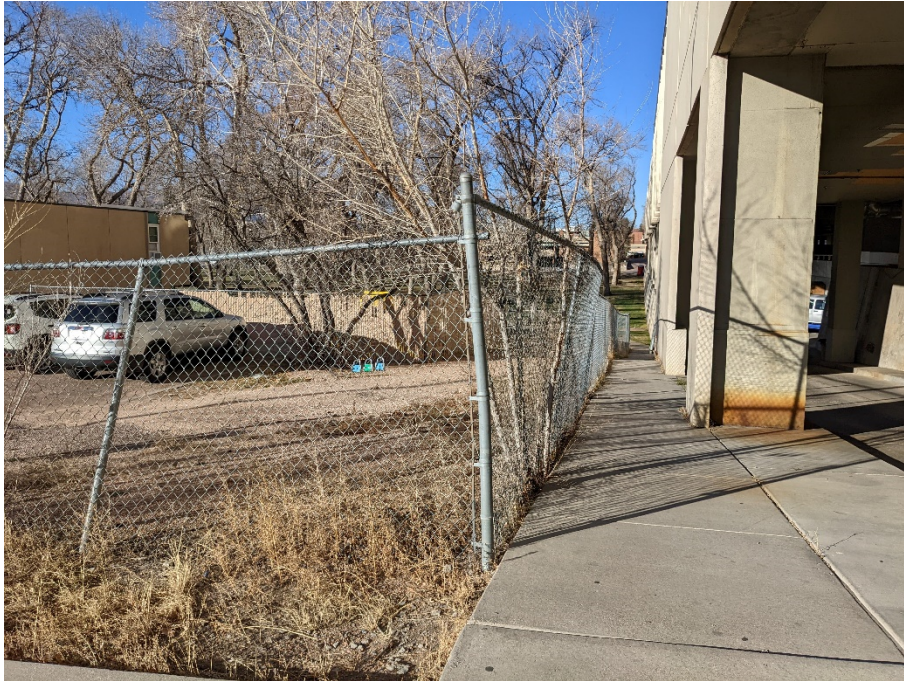
The current pedestrian connection between Antlers Place and Antlers Park

The site has a 30" sanitary sewer line running across the north west corner of the property with no utility easement. The site also provides pedestrian access between Antlers Place and Antlers Park along the east edge of the property shown in the photo below.

Parking has been minimized to include only enough parking for employees at the facility. The connection between Antlers Park and Antlers Place has been maintained and widened to allow for plantings and improved sight lines for pedestrian safety. The design team is hopeful that as future improvements are implemented at Antlers Park, increased foot traffic all around the site will create a safer environment for everyone in the area.

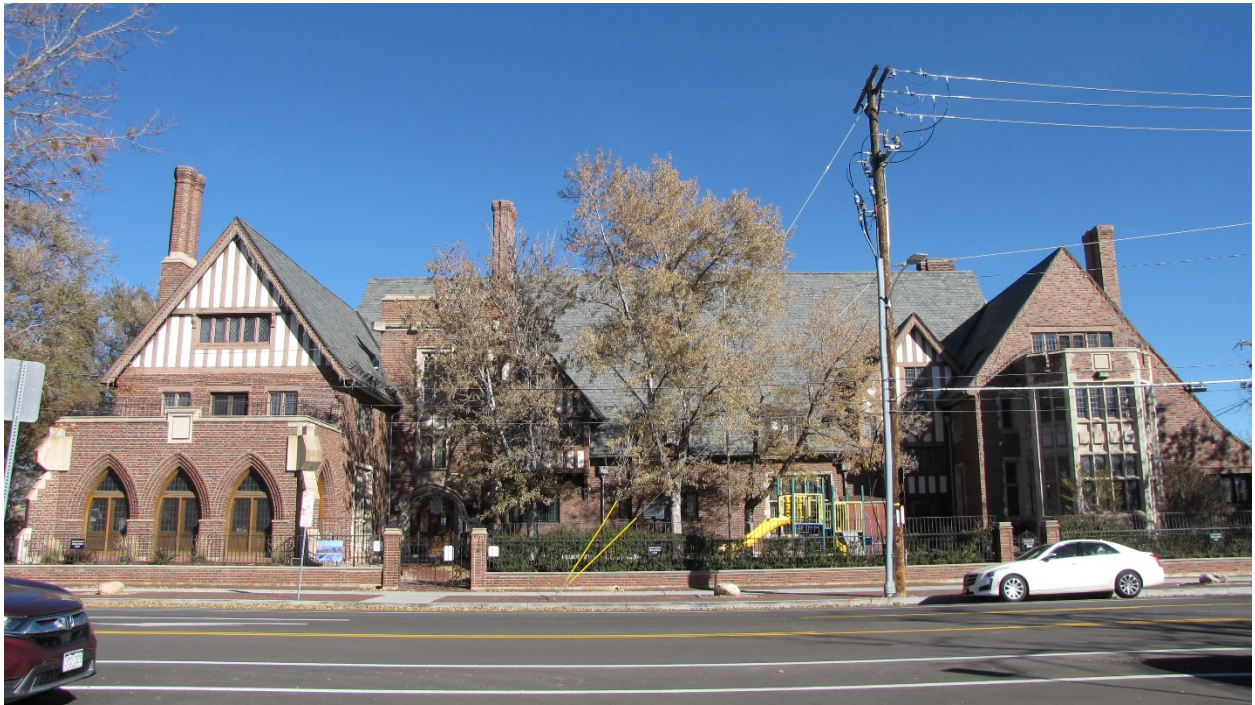
South façade of the historic day nursery building with playground and brick/iron fencing at sidewalk edge.

MSE type retaining walls will be used to protect the existing tree root system by eliminating a deep footing needed for a traditional retaining wall. A stamped brick pattern on the face of the MSE wall and stained concrete will be used to give the impression of a brick wall similar to the historic day nursery site wall and fence.

The historic day nursery building at 104 E Rio Grande St. is the design inspiration for the new facility. This 1928 building is not only a treasure to Colorado Springs but is a symbol of the mission of Early Connections Learning Centers to provide early childcare to working parents in need while providing a beautiful space for the children to spend their days. The design of the new facility reflects the Tudor mansion aesthetic with playful whimsy so the children know it was created just for them. As with the historic day nursery, the playground spaces will be front and center to provide a safe and interesting environment for the children. Vines growing up the walls of the historic day nursery building will also be used at the new facility to soften the edges of the new retaining walls along the parking lot and raised playground spaces.

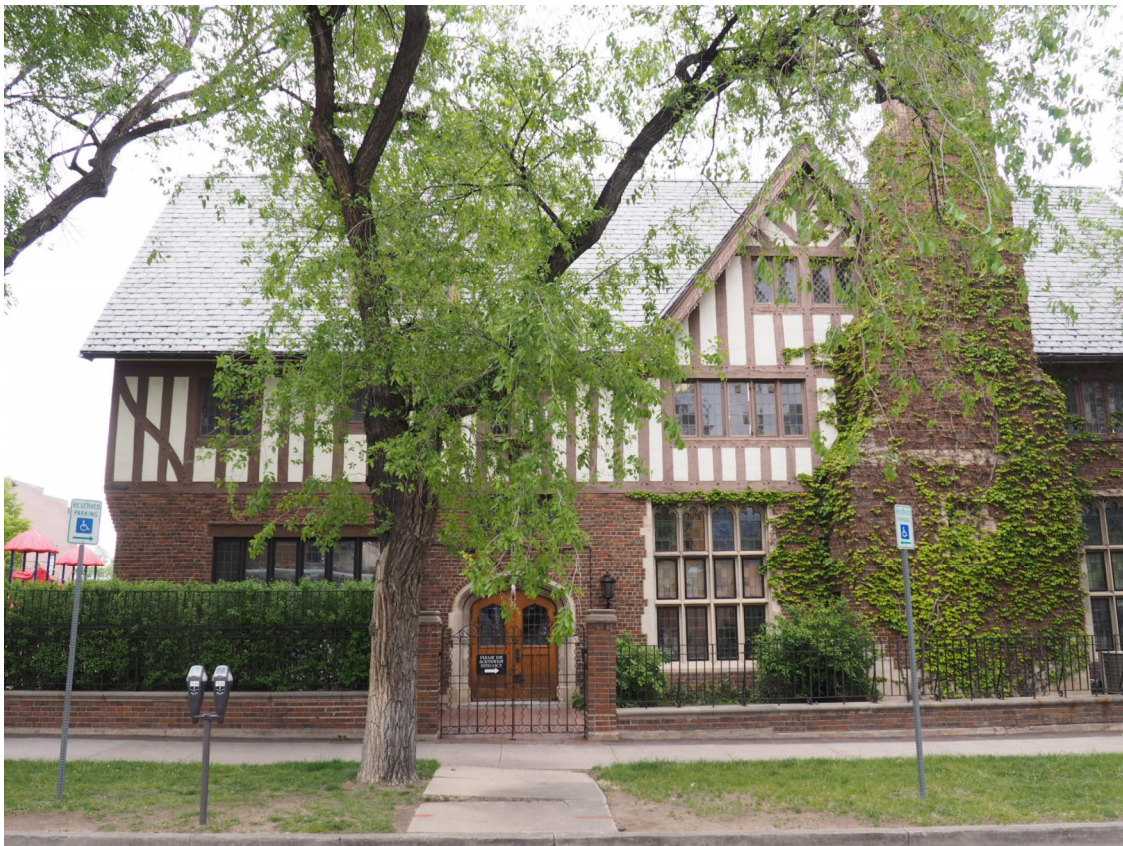
West façade of the historic day nursery building
